3-YEAR ASBESTOS RE-INSPECTION REPORT

SOUTH SCRANTON INTERMEDIATE SCHOOL SCRANTON, PA

PROJECT: #SSD.19_751

November 2019

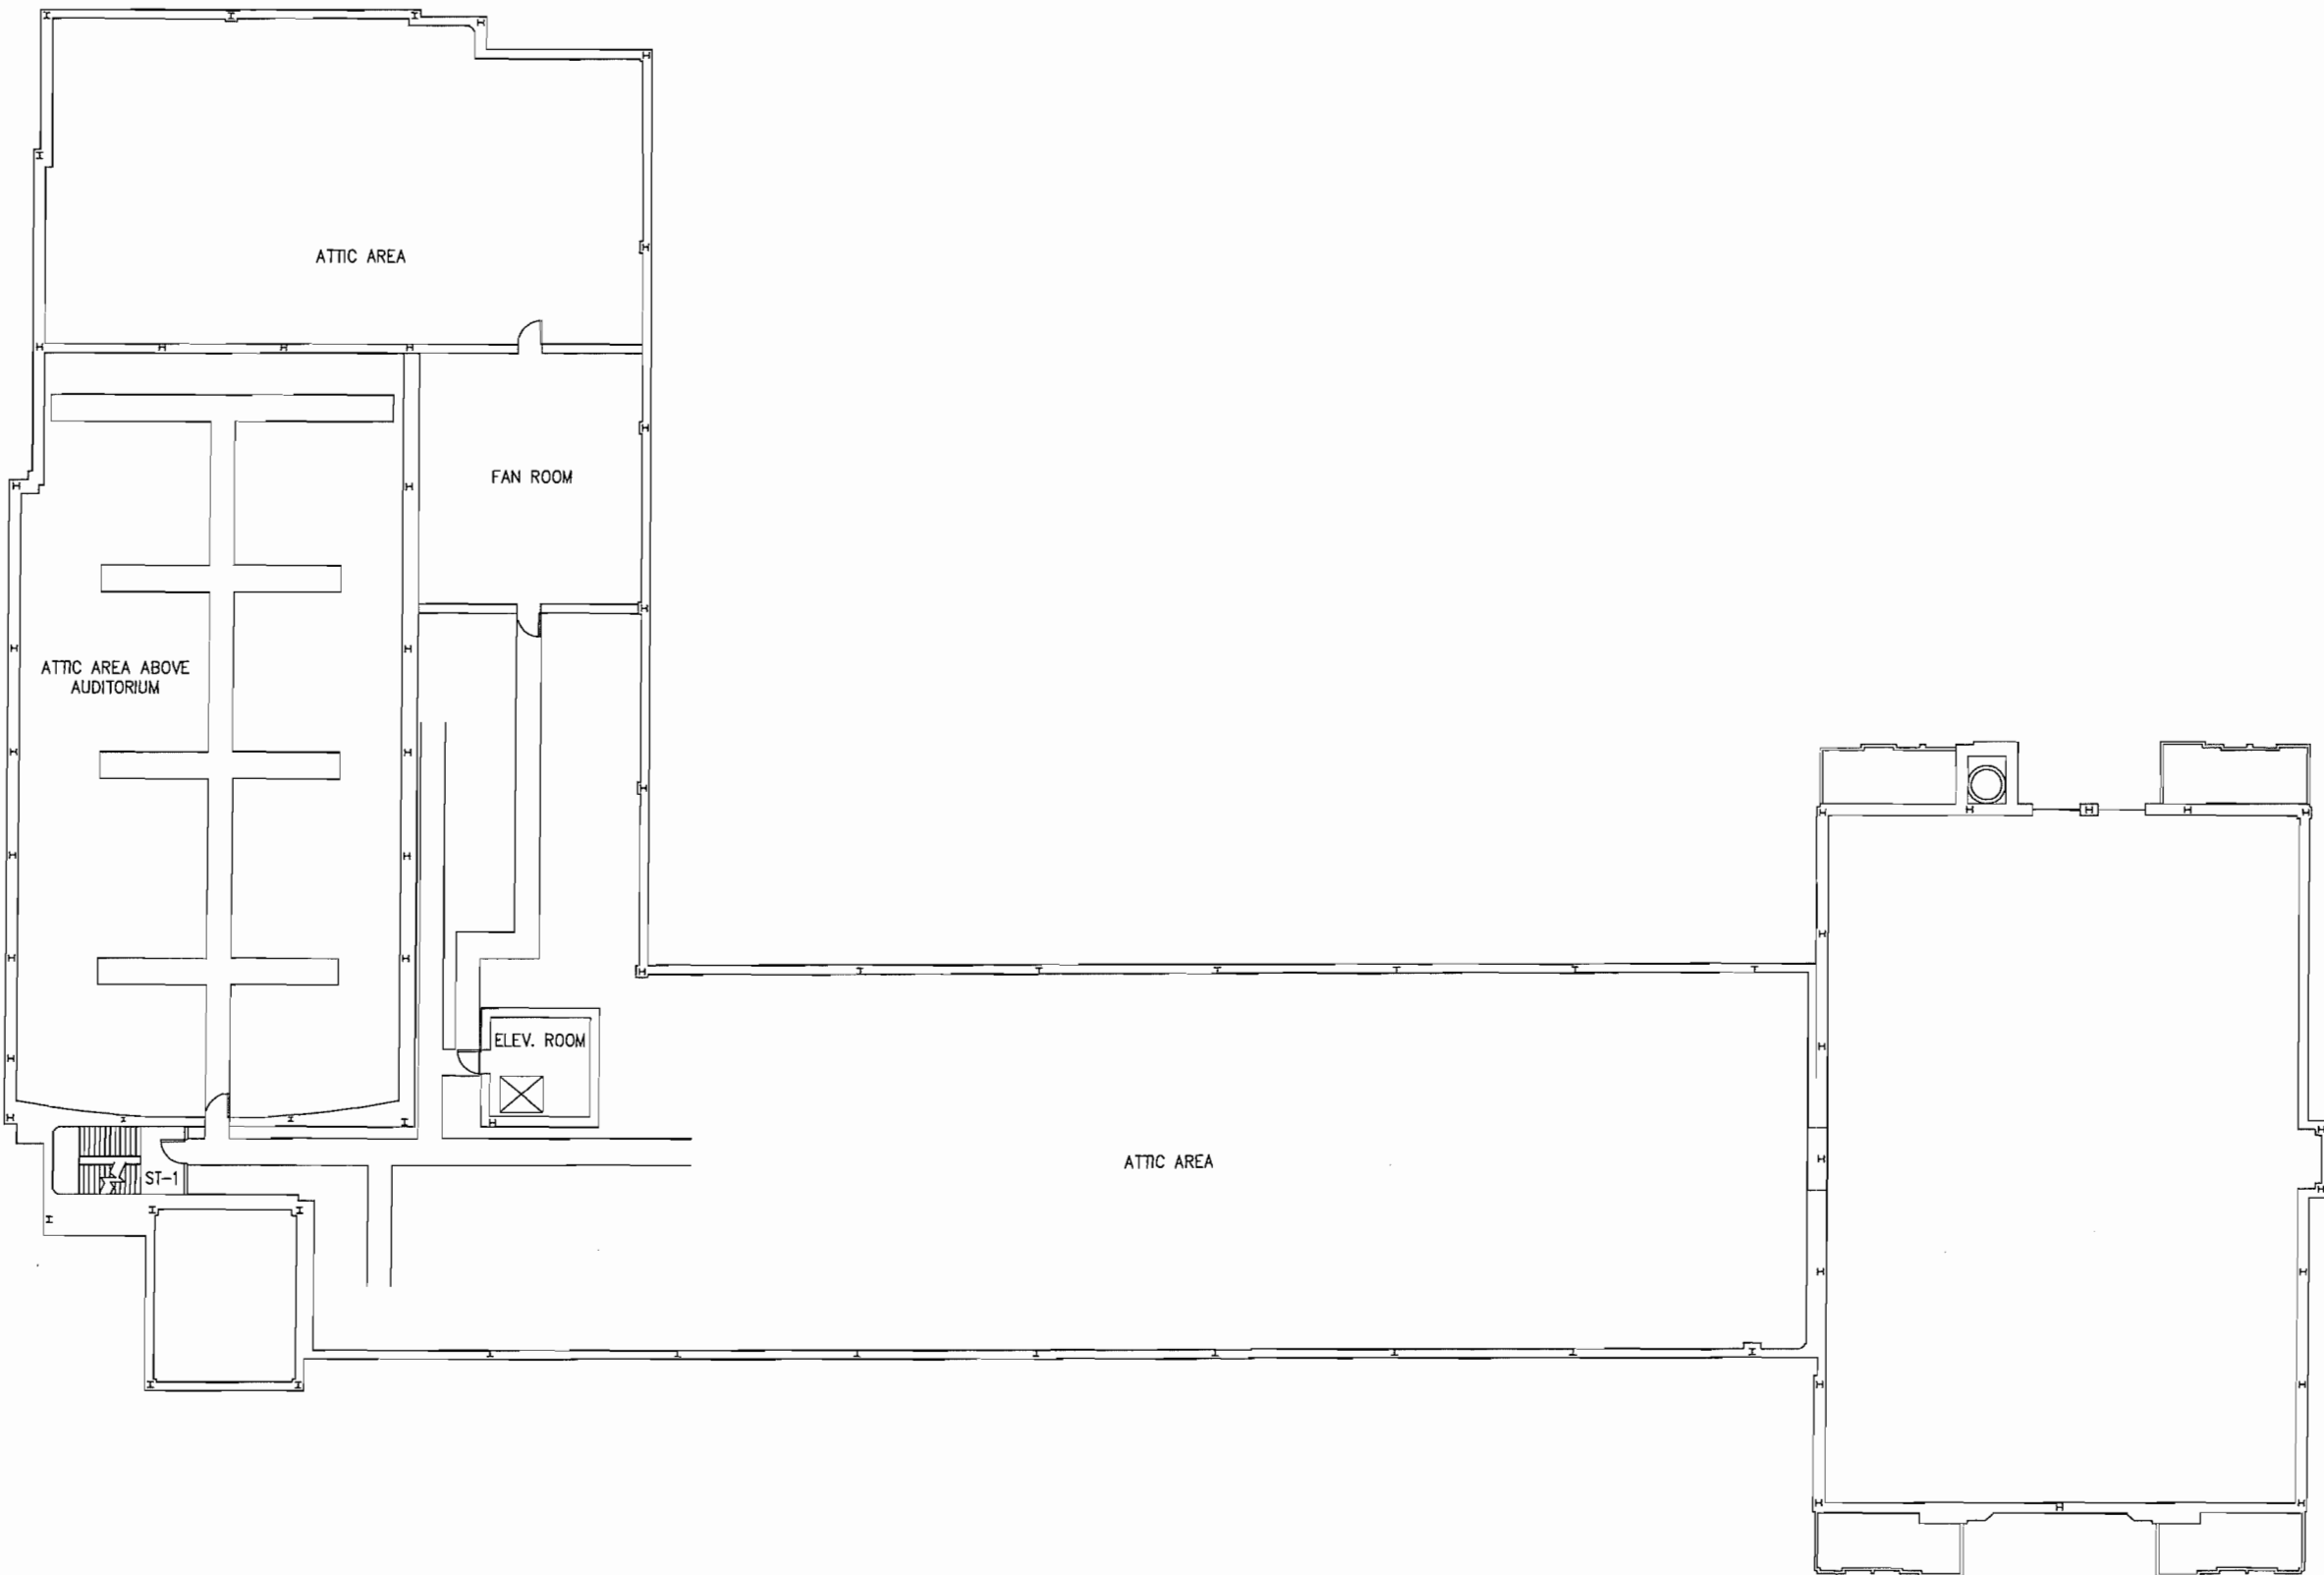
DRAWING No.:
**A
5**

KEY - SURFACING ACM
ASBESTOS CONTAINING
SURFACING MATERIALS WERE
NOT FOUND ON THIS LEVEL

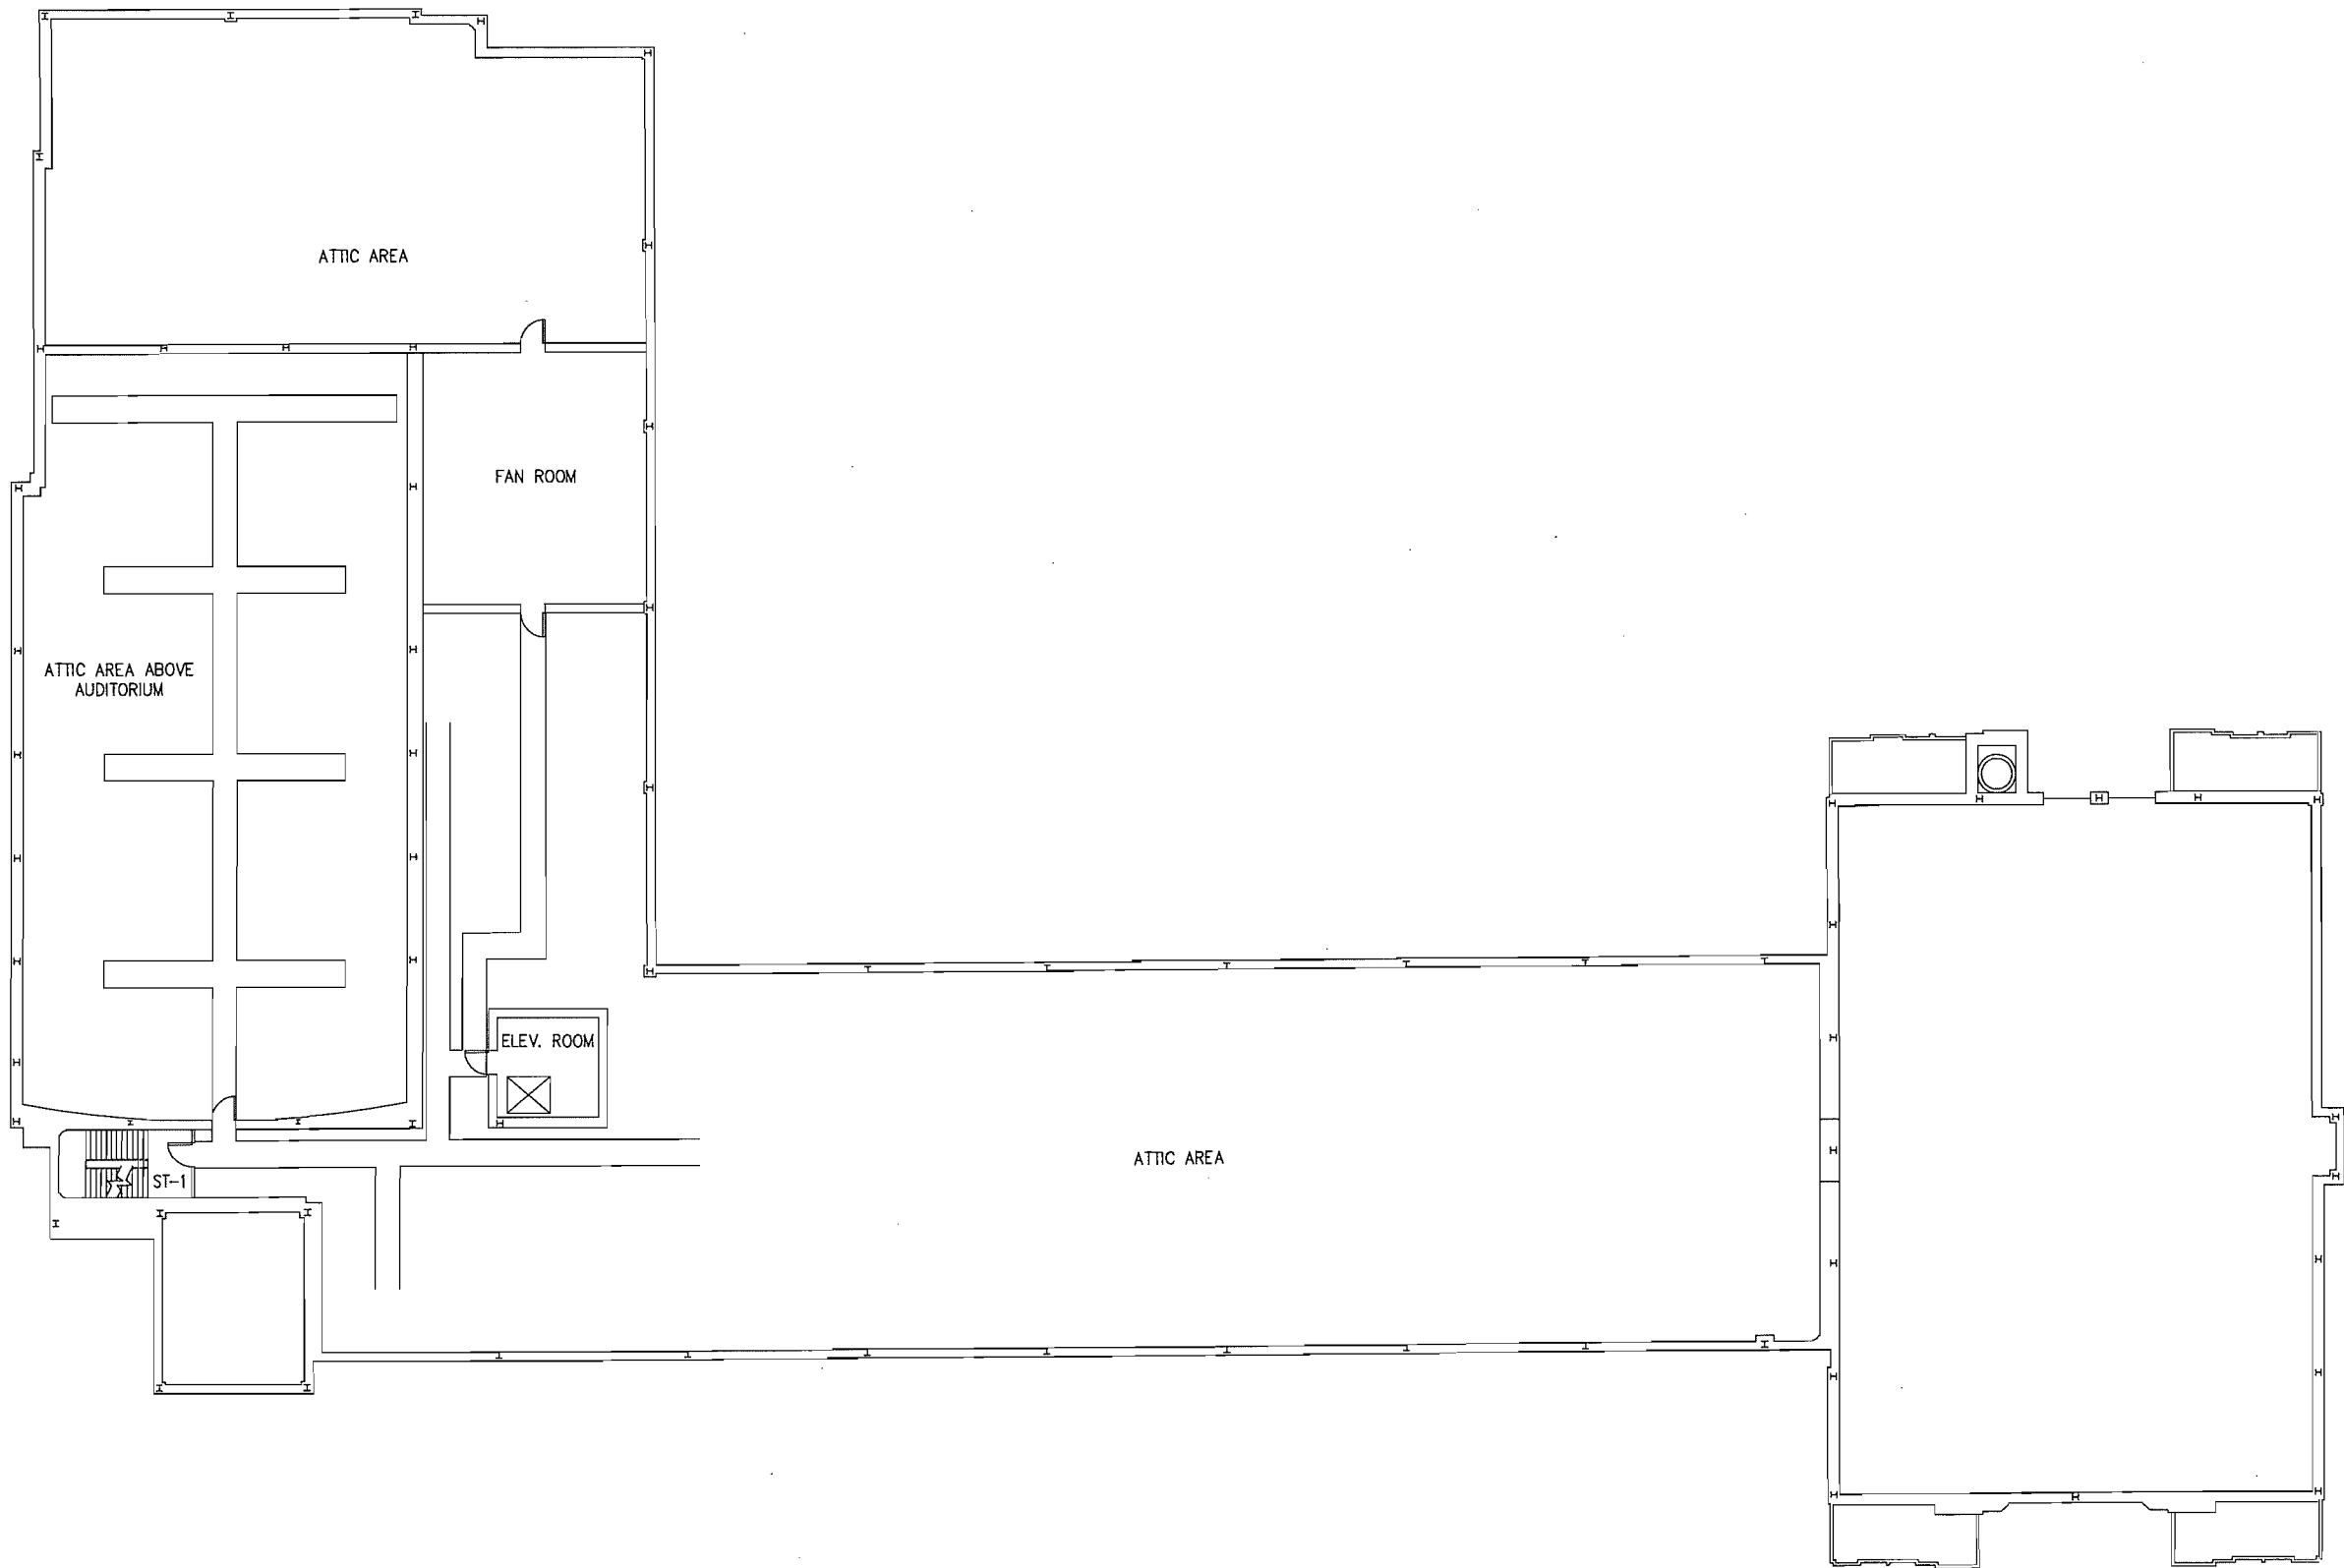
KEY — MISCELLANEOUS ACM
ASBESTOS CONTAINING
MISCELLANEOUS MATERIALS WERE
NOT FOUND ON THIS LEVEL
